# Village of Scarsdale Water System Master Plan

Westchester Water Works Conference, Oct. 12, 2022

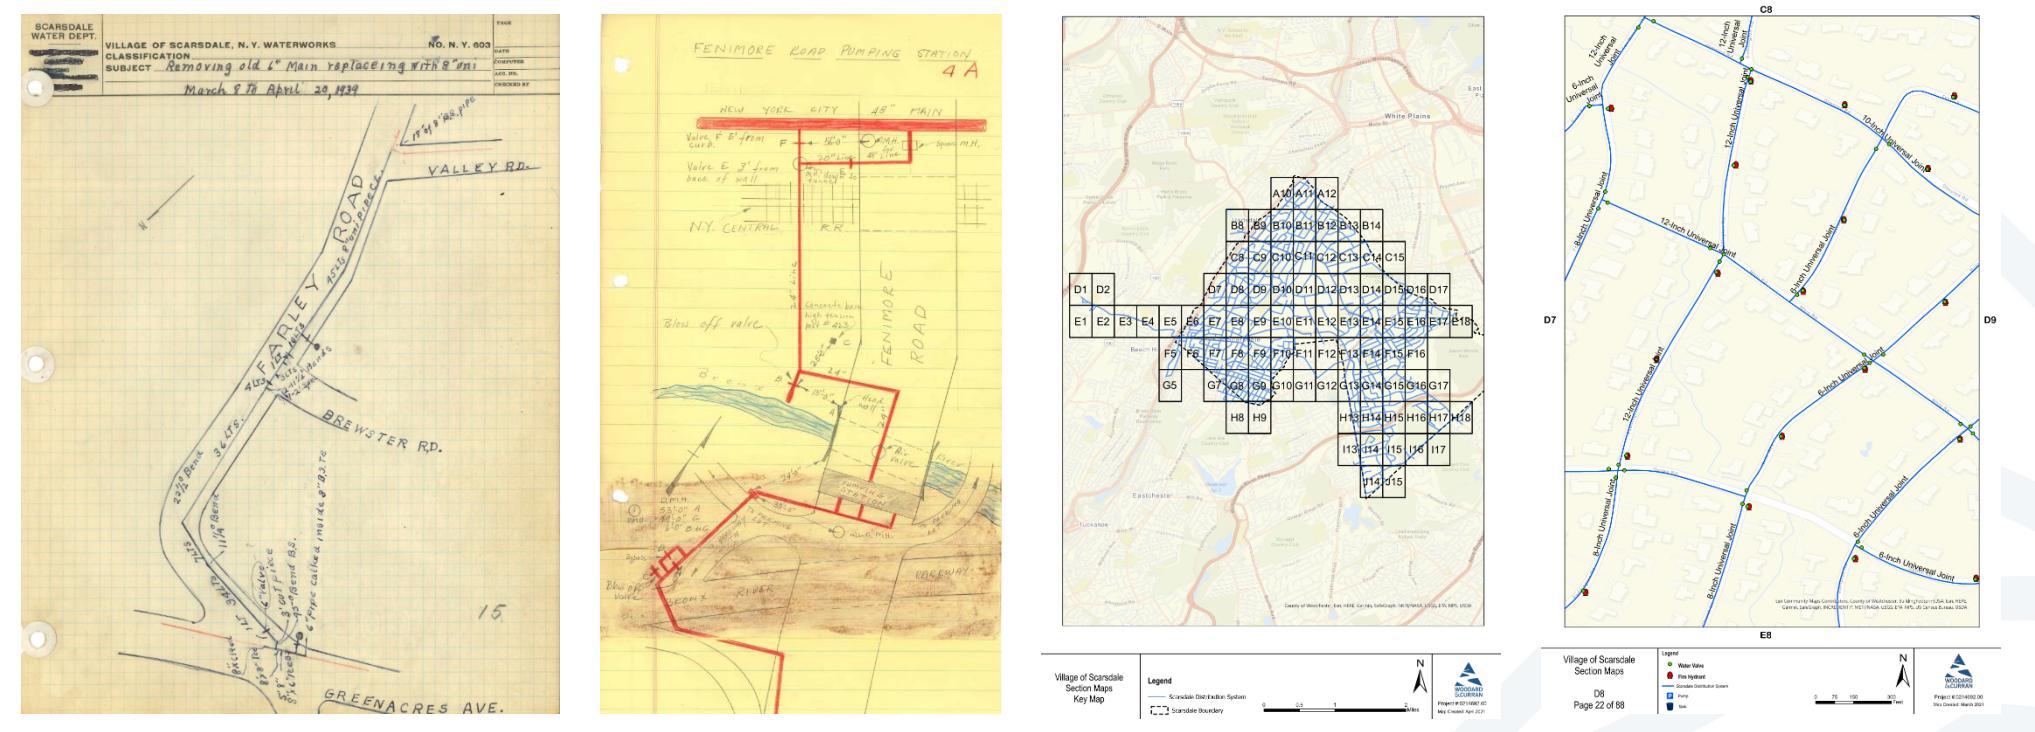
#### Data Review and System Mapping

- Compiled 500+ paper copy maps, field sketches, and notes
- Updated historic mapping with recent as-built information
- Updated mapping is the foundation for hydraulic model

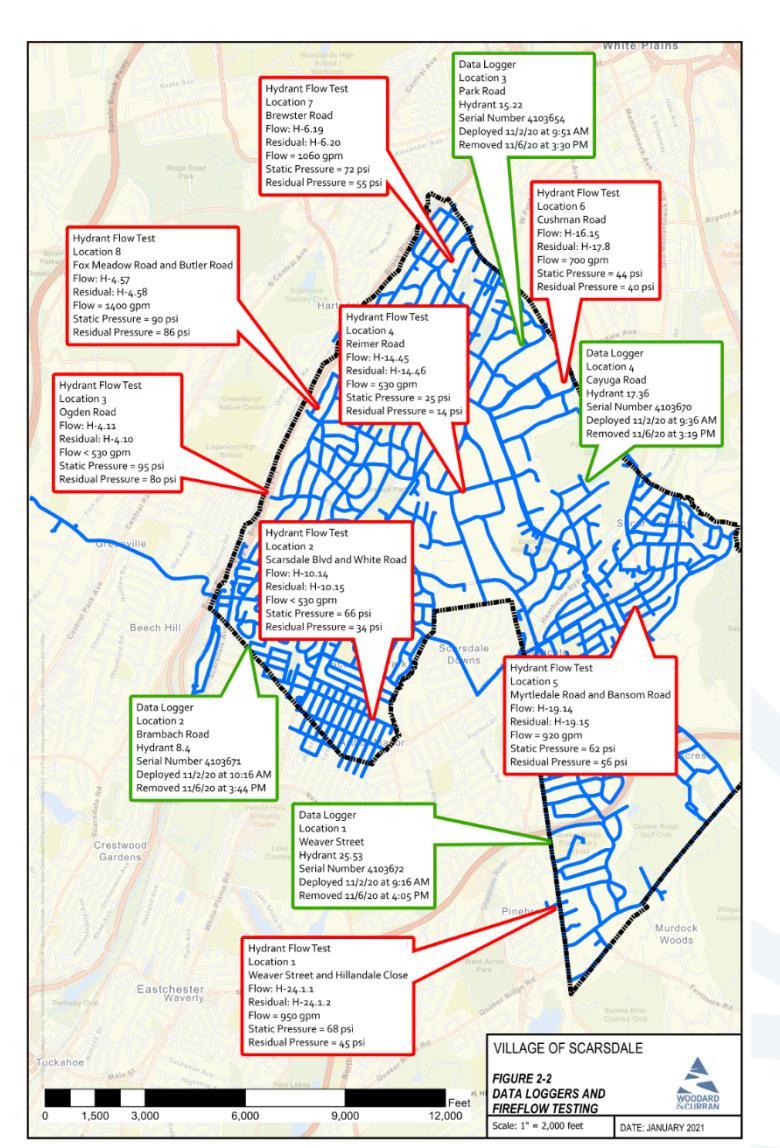
# Hydraulic Modeling

- Physical infrastructure represented from updated system maps
- Pumping and operational data obtained from SCADA
- Hydrant flow tests and pressure gauges for model calibration
- Evaluation Factors:
  - System Pressure
  - Pipe Velocities
  - Pressure Loss
  - Fire Protection
- 30-year demand projection

- System Pressure
  - >35psi except for high-elevation Murray Hill/Mamaroneck/Sheldrake area
- Pipe Velocities
  - No major issues of concern
- Pressure Loss
  - Worst in areas of unlined cast iron
- Fire Protection
  - Most of system is >1,000 GPM, <500 in high elevation areas with unlined CI pipe
- ► 30-yr demand projection (+5.2%)
  - No new issues, but wider extent

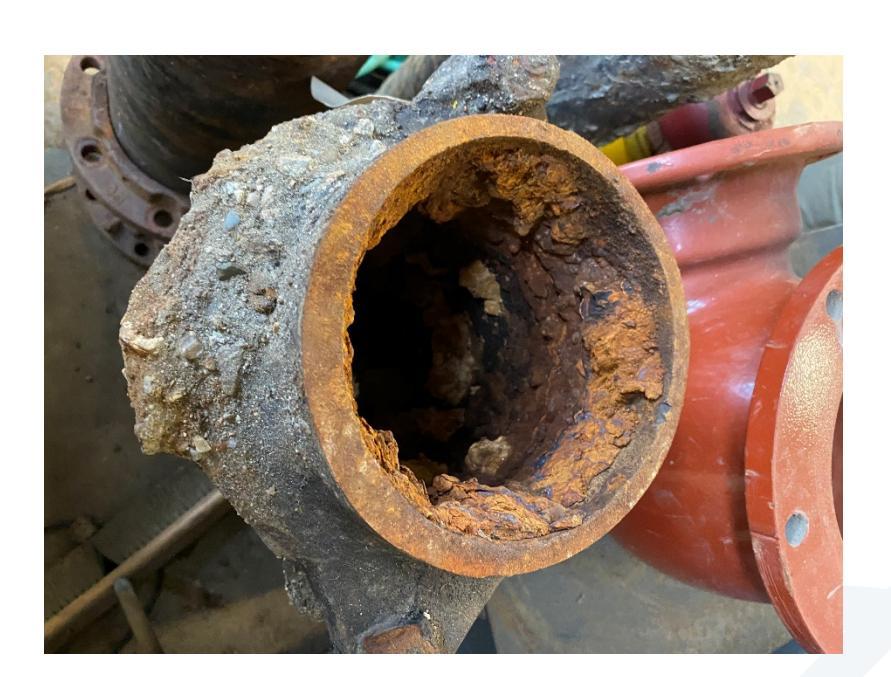
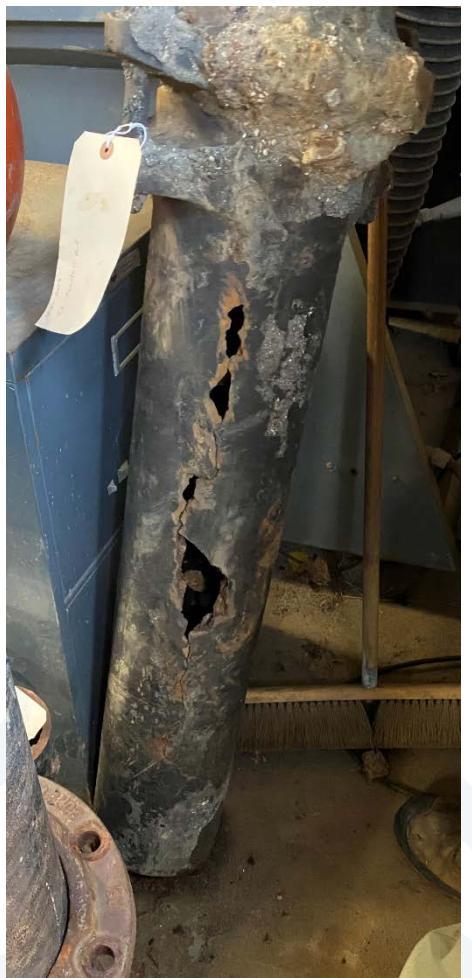
#### **Review of System Maintenance History**

- Geographically distributed across the system with some "hot spots"
- Pattern of issues with universal joint and unlined cast iron pipe
- Repair frequency did not correlate with pipe size
- 200 main breaks and valve failures from 2008 to mid 2020
